NATIONAL PROGRAM FOR INSPECTION OF NON-FEDERAL DAMS
SILVER LAKE DAM (ME 0. (U) CORPS OF ENGINEERS WALTHAM
MA NEW ENGLAND DIV OCT 78

SILVERLAKE DAM

PENOBSCOT RIVER BASIN
BUCKSPORT, MAINE

PHASE I INSPECTION REPORT
NATIONAL DAM INSPECTION PROGRAM

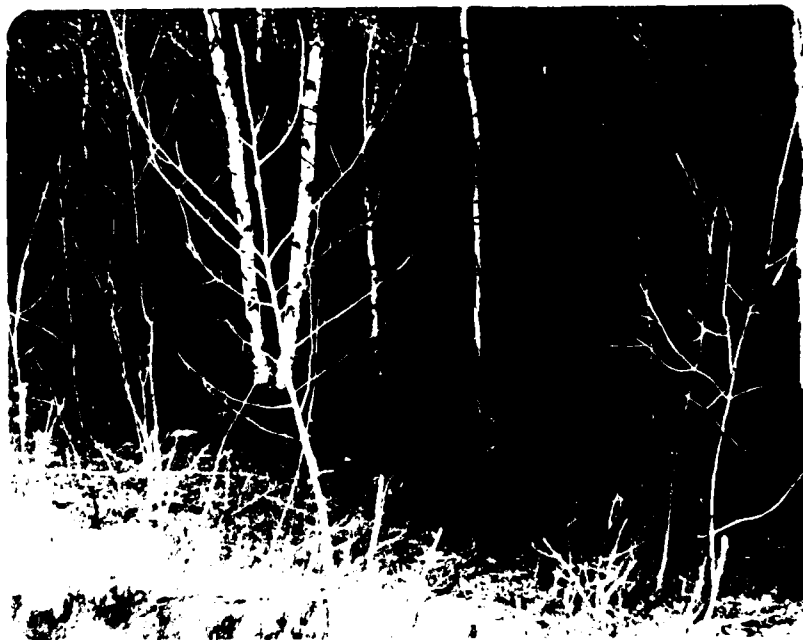
No. 8

seepage water was very cold and was rust colored. The discoloration of the water in the pool and on the ground surface is caused by precipitation of iron minerals, (upon contact with air) from the seepage flows. The seepage emergence area overlaps the buried cast iron pipes. Some seepage could be following along these pipes. A lesser quantity of seepage was observed flowing from the left embankment toe at the intersection of the embankment and left discharge channel wall. This seepage was also flowing clear. No seepage was observed flowing from the embankments.

(1) The dam, approximately 50 years old, showed no signs of sloughing or erosion of the embankment or the abutment slopes. The vertical as well as horizontal alignment of the crest showed no signs of distress and no cracks or unusual movement, including rip-rap failure and/or dislocations were visible. Some vehicle caused rutting (about 6" deep) was observed on the crest of the right side embankment. Shrubs were noted growing on the upstream and downstream slopes of both embankments while several large trees (up to 12" dia.) were noted on the downstream slopes. (See photo nos. 2 and 8).

(4) Seepage emergence was noted near the downstream toe of the right embankment. The seepage was ponding in a shallow pool over a length of about 70 feet (see plate B-1 and photo no. 8). The seepage was flowing clear indicating that material piping was not occurring. The

FOUNDATION SEEPAGE (ORANGE COLORED) AT DOWNSTREAM
TOE OF RIGHT SIDE EMBANKMENT

(3) The two cases of seepage observed are not considered to have an adverse effect on the structural integrity of the dam at this time, but should be closely monitored for cloudiness or any increase or decrease in quantity relating to reservoir stage which could require prompt corrective action.

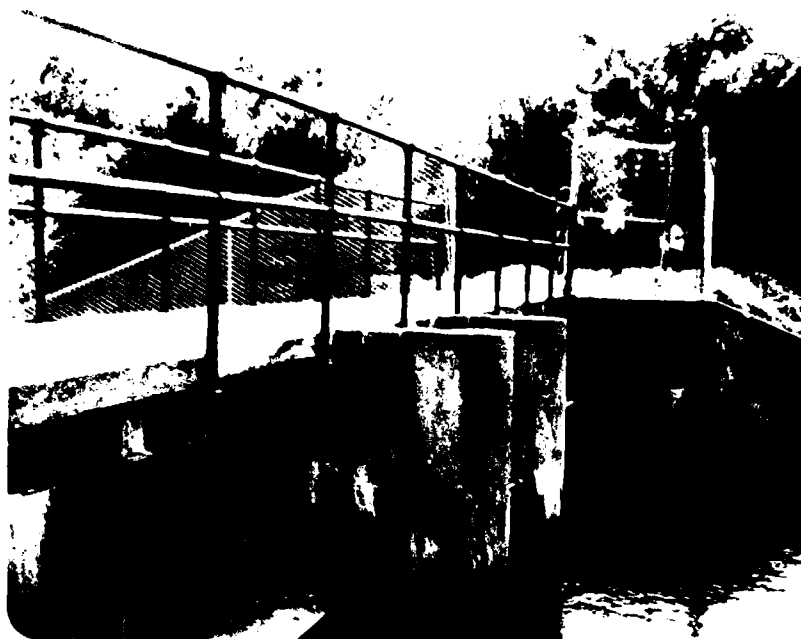
No. 5

VIEW LOOKING WEST AT UPSTREAM SIDE OF SPILLWAY &
SERVICE BRIDGE
